## POST-FIRE EVALUATION REPORT OF FINDINGS

### MULLICAN RESIDENCE

6000 COUNTRY RIDGE LANE  
NEWALLA, OKLAHOMA 74857

JUNE 6, 2021

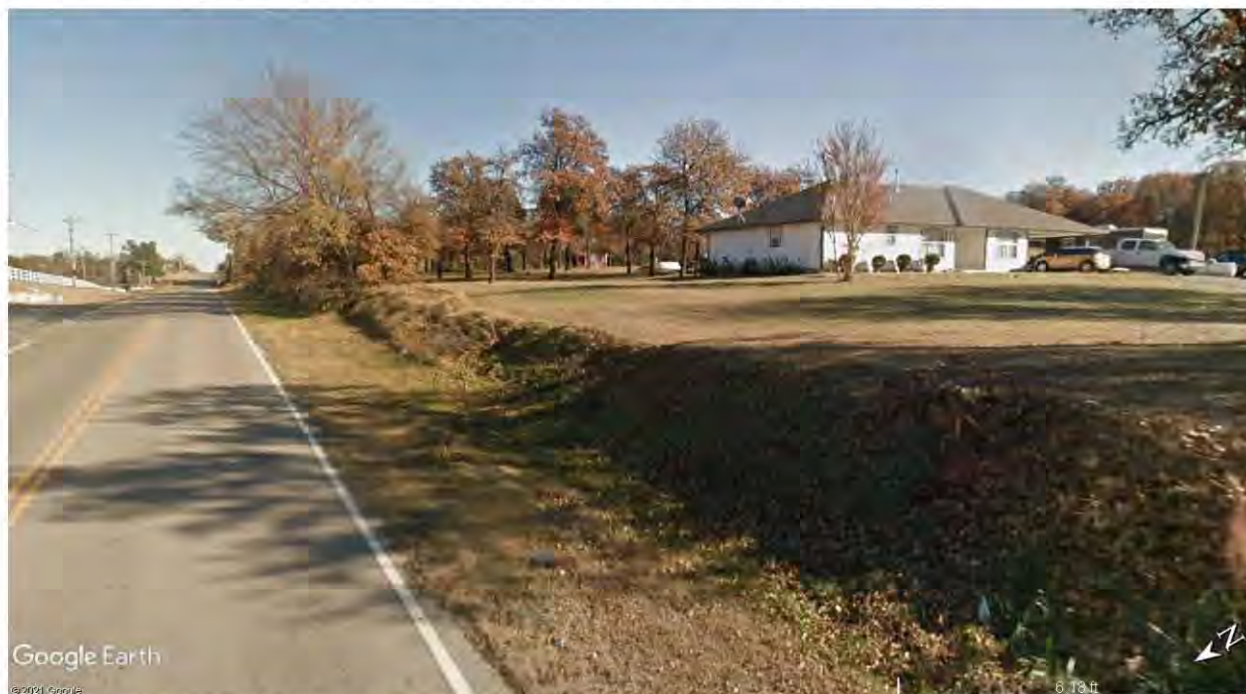
Figure 3.4.2.1: Google Earth Street View Image dated November 2015.

As part of the review of historical images relative to the property, Valor FES reviewed Street View images from Google Earth. The Street View Image dated November 2015, included as Figure 3.4.2.1 (below) shows that the primary west facing windows had curved arch tops. For clarity, Figure 3.4.2.2 (also below) is a cropped version of the images in Figure 3.4.2.1 focused on the subject dwelling. The curved front (west) windows are marked with red arrows.

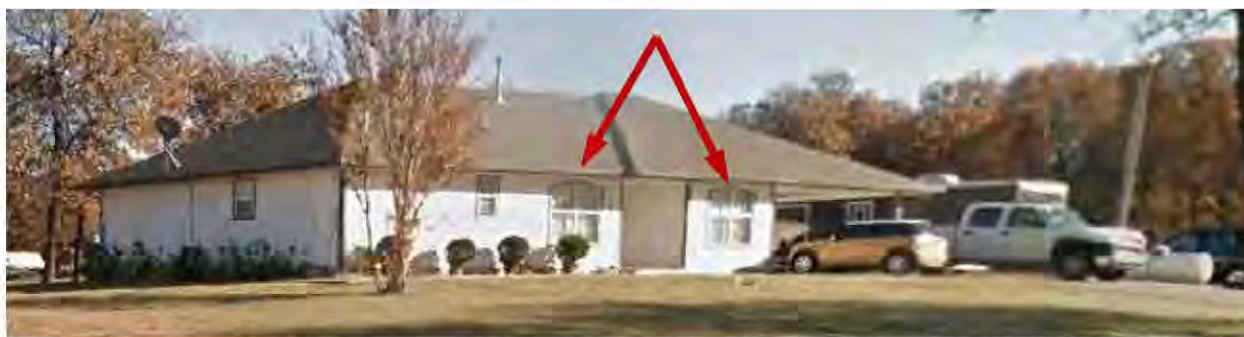
Figure 3.4.2.2: Cropped and enlarged portion of the digital image in Figure 3.4.2.1. The location of curved windows for the west elevation are marked with red arrows.

Valor FES was provided with a copy of State Farm estimate which included the date of '5/6/2021' on the lower left corner (included as Attachment E: State Farm Estimate). This estimate indicated that it was for fire damage reported October 15, 2020. The estimate included the removal and replacement of the windows for the 'front bedroom', 'hall bathroom', 'back bedroom', 'living room', 'dining room', 'kitchen', 'laundry room', 'master bedroom', and 'master bathroom'. Part of this estimate included costs for 'retrofit' windows. 'Retrofit' windows are commonly replacement windows and are installed within the original window flange. This type of window will not restore the dwelling to the pre-fire condition as they represent a different type of installation. **If the intent is to maintain an 'as constructed' exterior flanged windows, it will be necessary to remove the existing siding, restore the underlying moisture resistant barrier, and then install the new windows and flashing.**

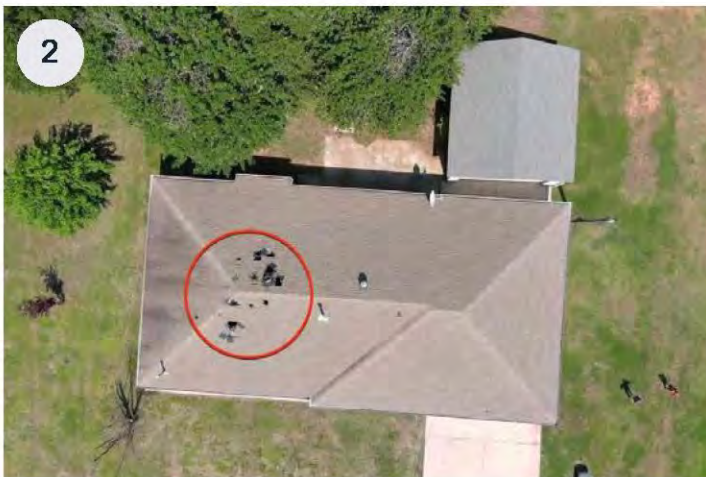
Aerial view of the dwelling from a Valiant Technical Services UAV (Drone). Note that portions of the roof deck and shingles had burned through (circled).

1. Removal and reconstruction of the laminate-style asphalt-composition shingle roof surfaces in their entirety. It will also be necessary to remove and replace the charred/delaminated roof decking along the northern approximately 50-feet of the dwelling.

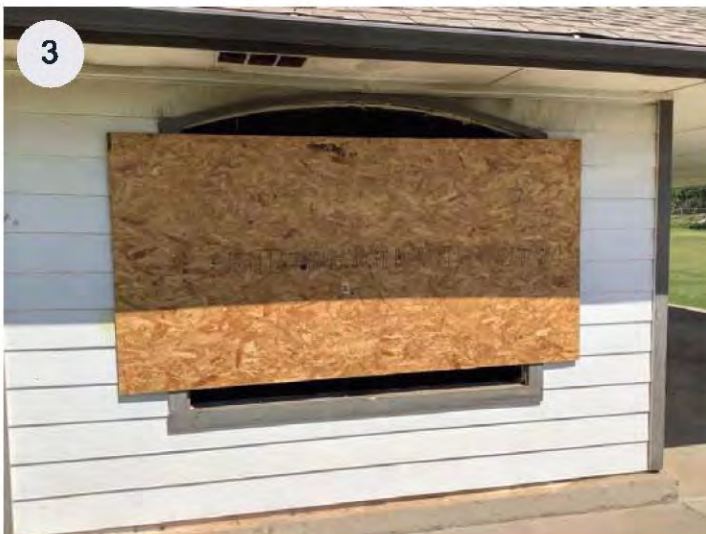
View of an OSB panel installed over the window located at the southwest corner of the dwelling.

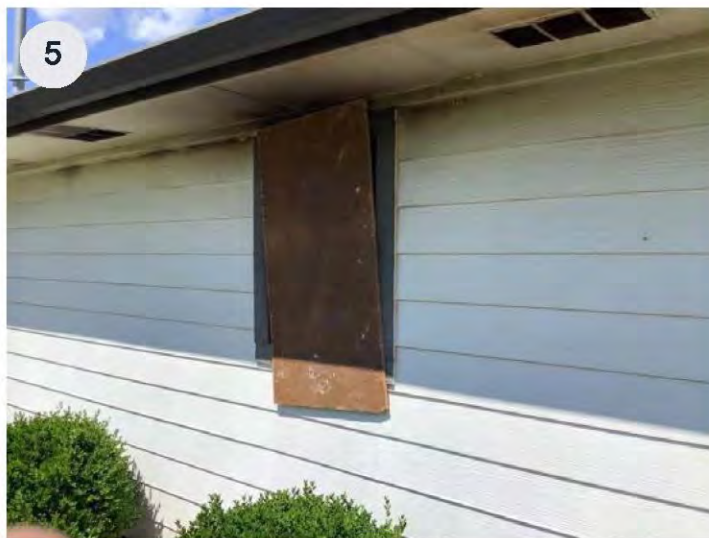
View of a wood fiber panel installed over the northern window of the west elevation.

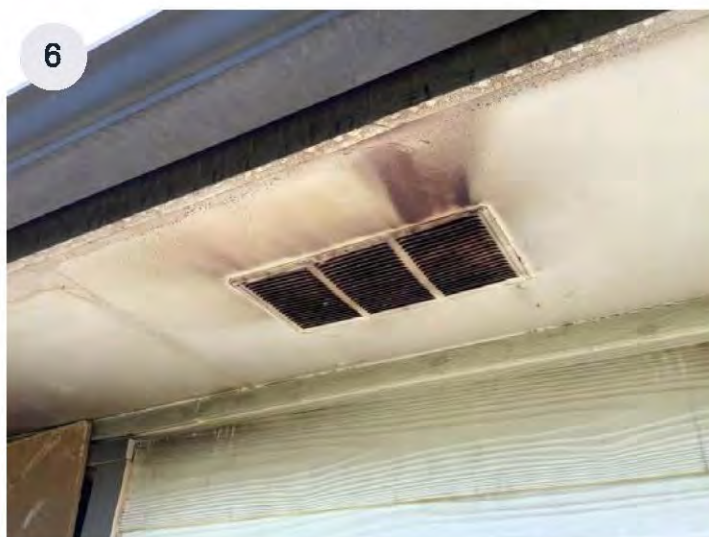
The attic of the dwelling was vented in part through a series of linear soffit vents. Heavy soot and partially displaced finishes were noted around the various soffit vents. The soffits and fascia along the east side of the dwelling were partially consumed and charred. The framing which supported the sheathing/soffits was also burned/charred. The soffit vents were sagging which was consistent with damage from heat.

View of soot driven along the perimeter of the soffit vents.

5. Removal and reconstruction of the doorframe from the living room to the back (east) covered porch.
6. Removal and replacement of the sections of the soffit and fascia panels along the perimeter of the dwelling due to the accumulation of soot, the areas of heat damaged finishes, and the full loss of the section along the east side of the dwelling. This also includes sections of the gutter which were deformed from the heat and where the coatings had burned off along the perimeter.

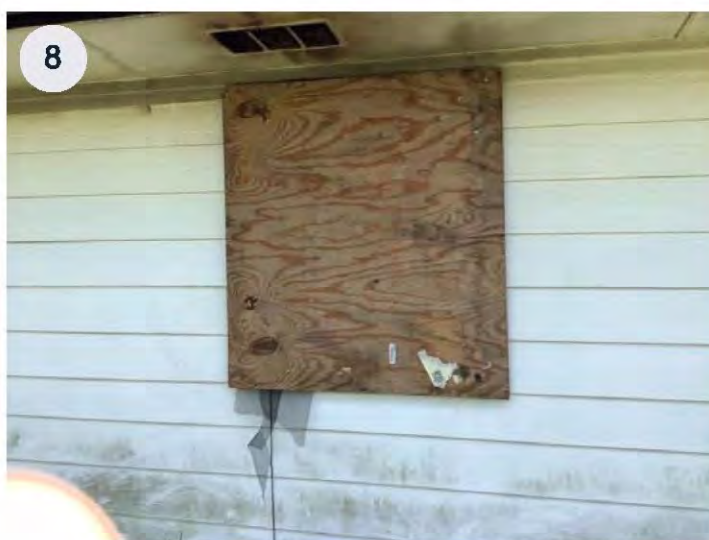
The north window of the dwelling had been covered with a wood panel.

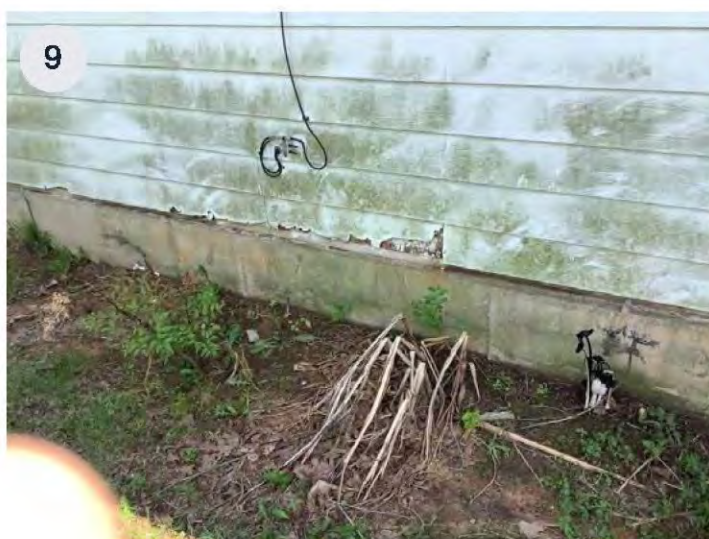
The exterior of the dwelling was clad with a wood-fiber wood look siding. Portions of the lower edges of the siding were in deteriorated condition.

The fiber siding along the base of the north elevation was deteriorated.

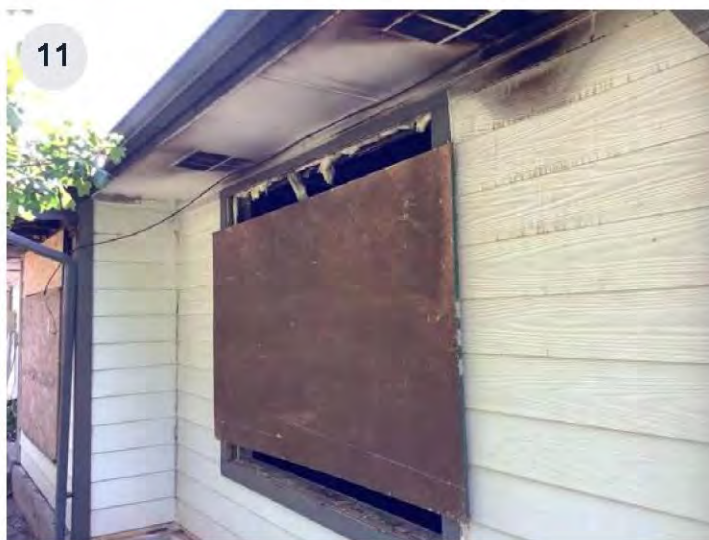
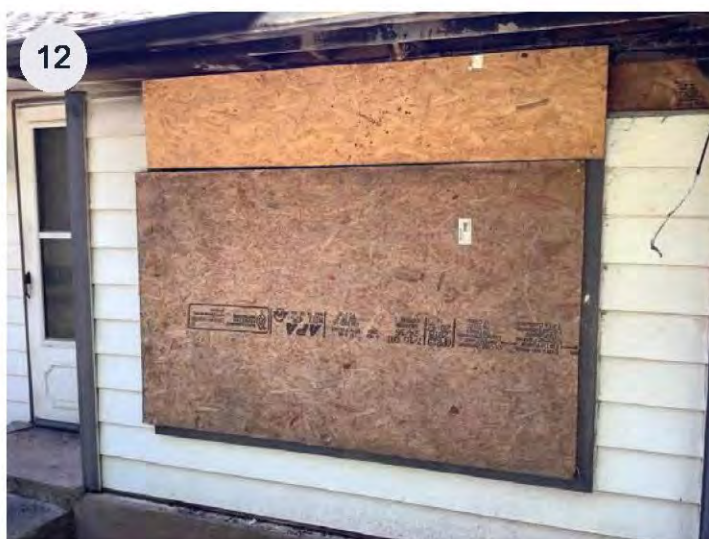
View of wood panels which had been placed over the back (east) elevation windows.

7. Removal and replacement the perimeter windows of the dwelling. If the intent is to maintain exterior flanged windows (as originally installed), it will be necessary to remove and replace sections of the exterior siding and underlying moisture resistant barrier. Given the extent of the siding demolition which would be needed to maintain the flanged windows, the full removal and replacement of the exterior siding should be considered.

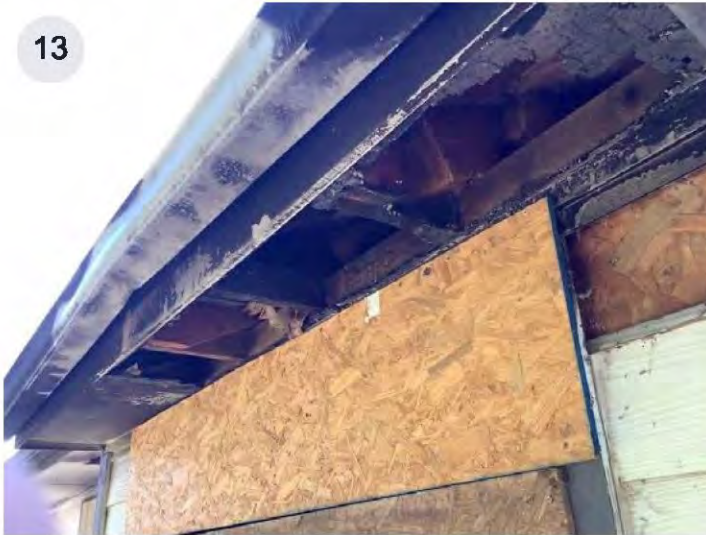
View of burned sections of soffit panels, fascia panels, and framing located to the east of the kitchen.

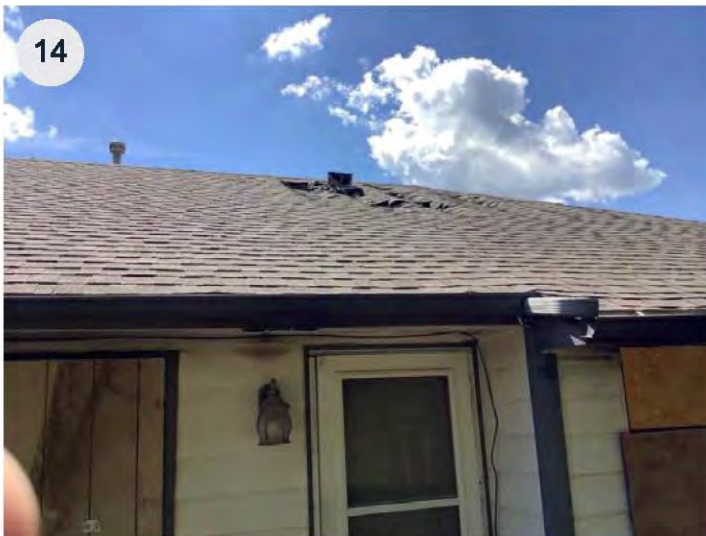
View of burned roof sheathing and shingles along the ridge at northern end of the dwelling.

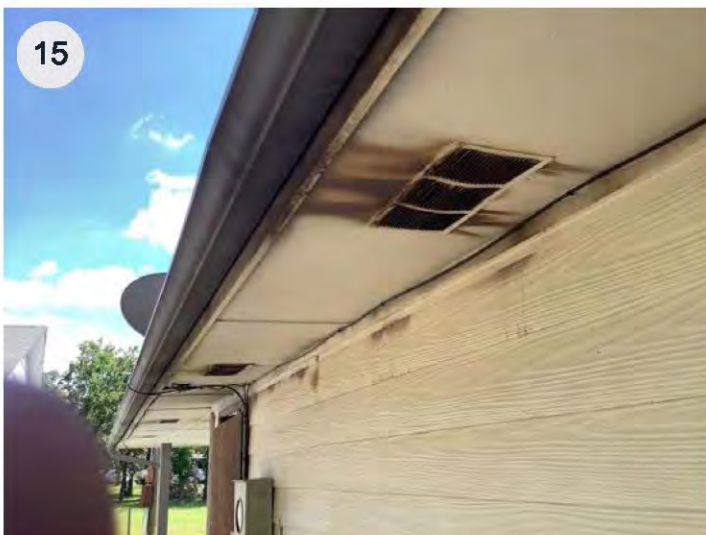
View of soot which accumulated along the perimeter of the soffit vents.

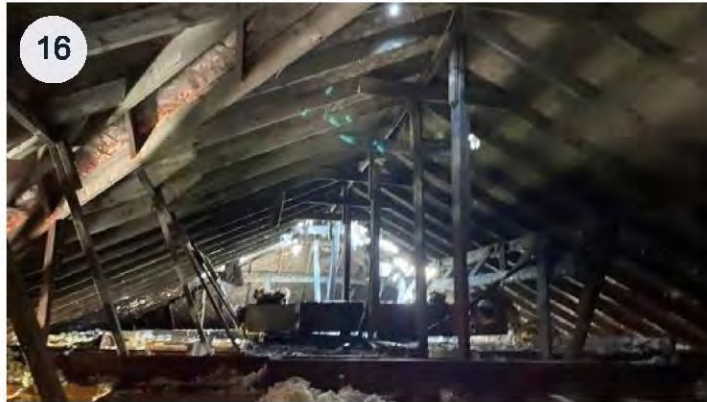
Overview of the attic from the south end of the dwelling. The sections of daylight were from locations where the roof decking and shingles had burned through.

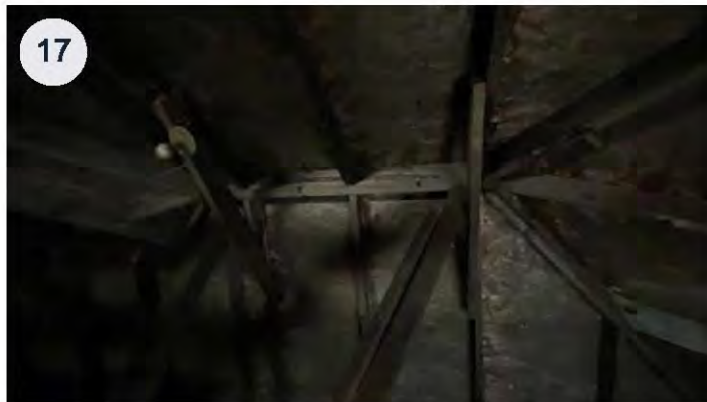
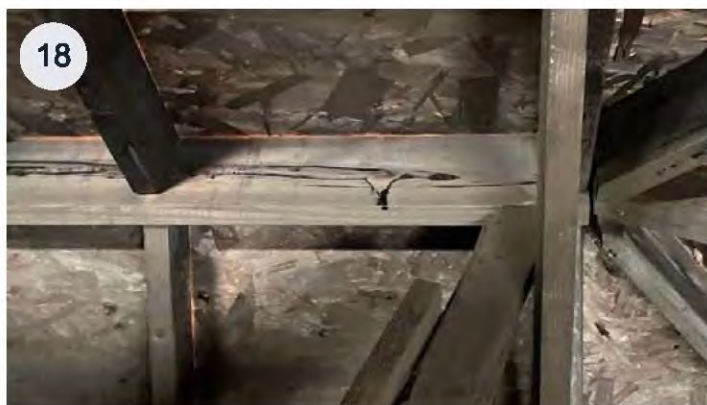
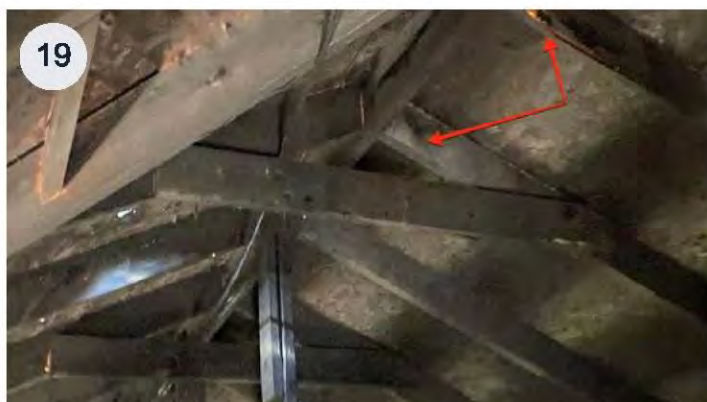
View of sap which had released and burned along the lower sections of the primary ridge beam.

View of sap which had released and burned along the lower sections of the primary ridge beam (red arrow).

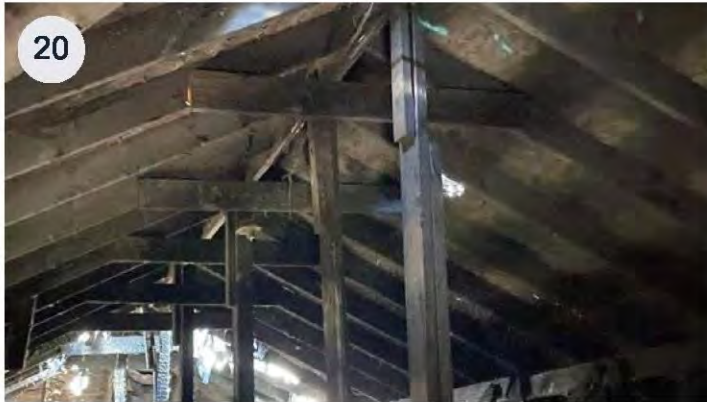
View of soot along the south end of the attic framing.

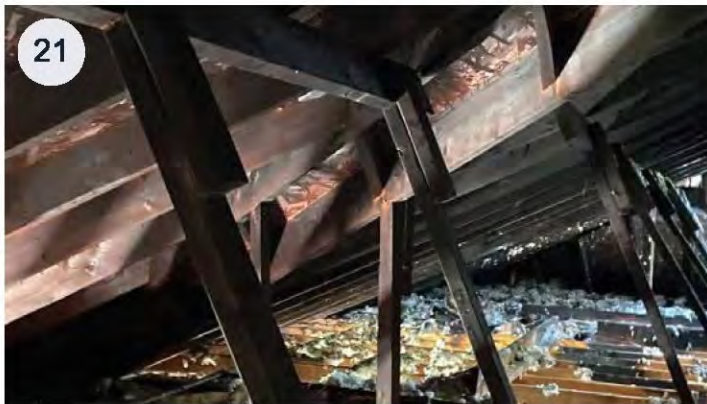
View of accumulated soot along the south ridge and rafters.

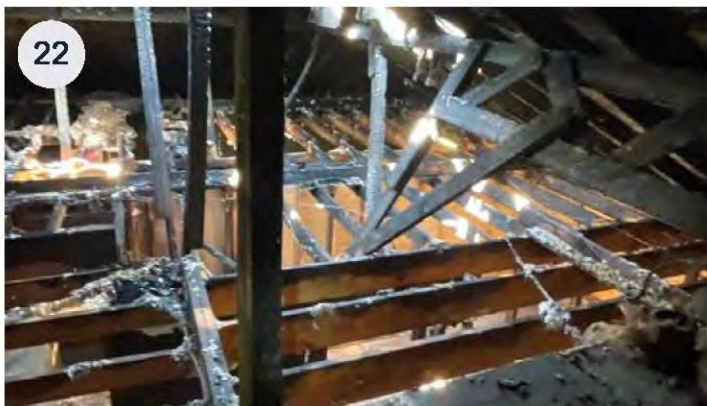
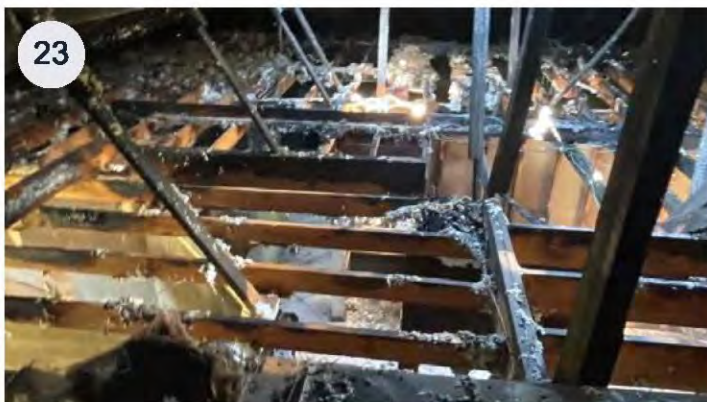
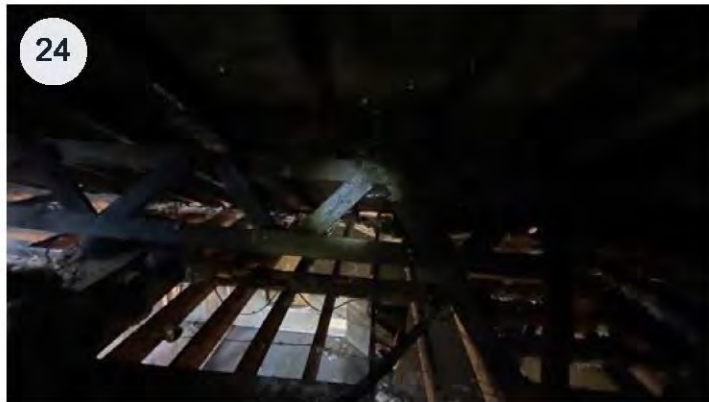
View of charred ceiling framing in the area above the kitchen.

3. Removal and reconstruction of the roof and ceiling framing over the northern approximately 50-feet of the dwelling due to the charring of the members and the observed heat damage.

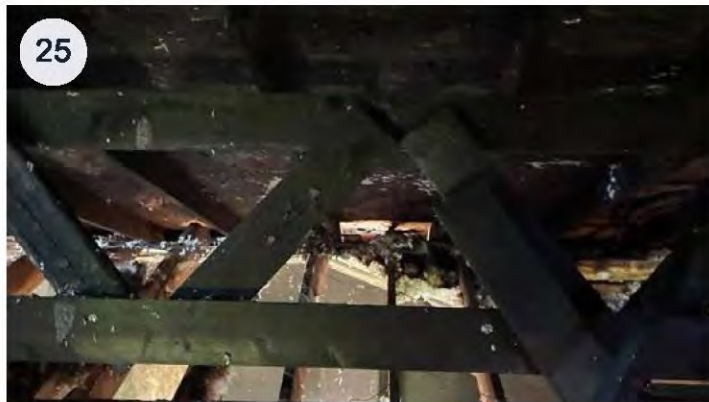
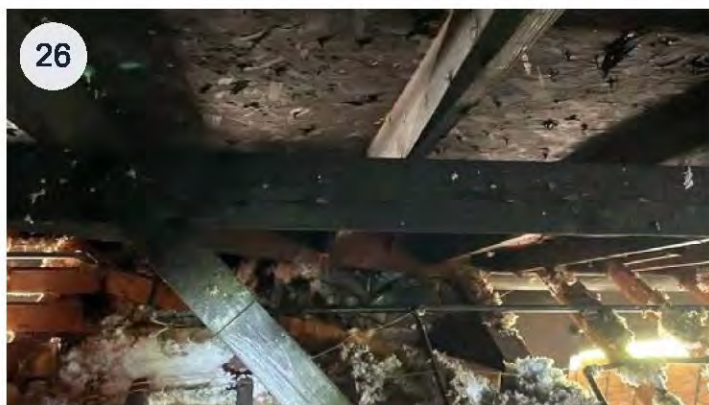
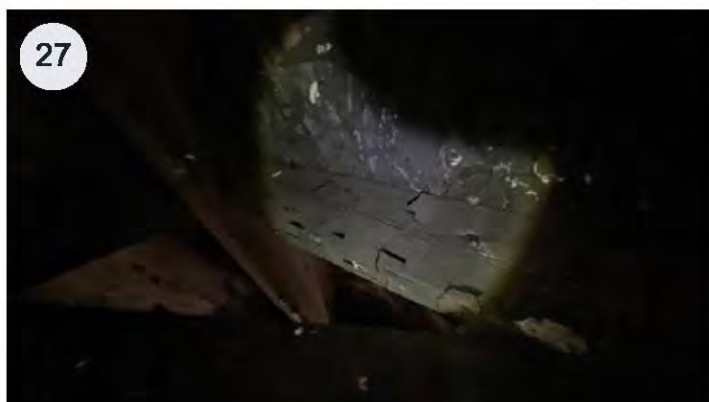
View of charred framing extending above the living room.

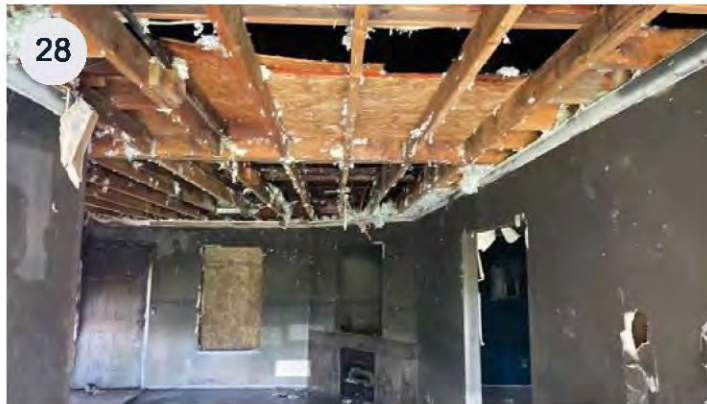
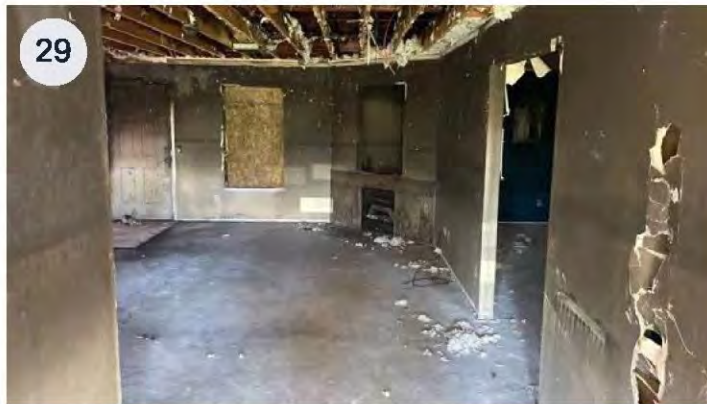
View of the displaced wall board ceilings above the living room.

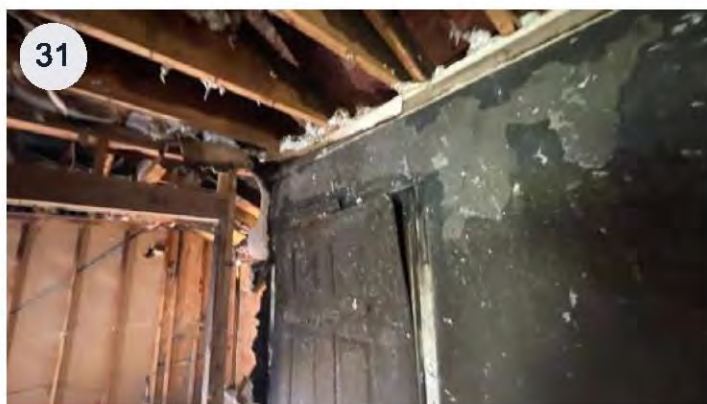
The wood framing for the east doorway from the living room was charred.

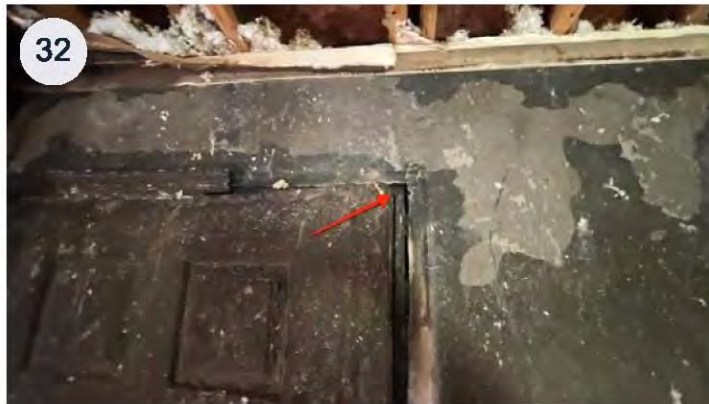
The wood framing for the east doorway from the living room was partially charred.

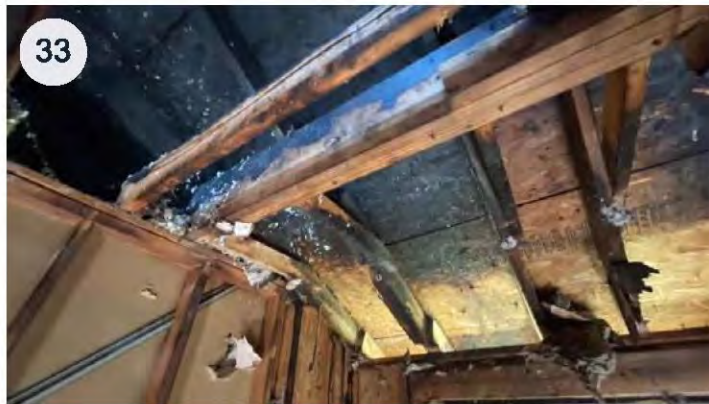
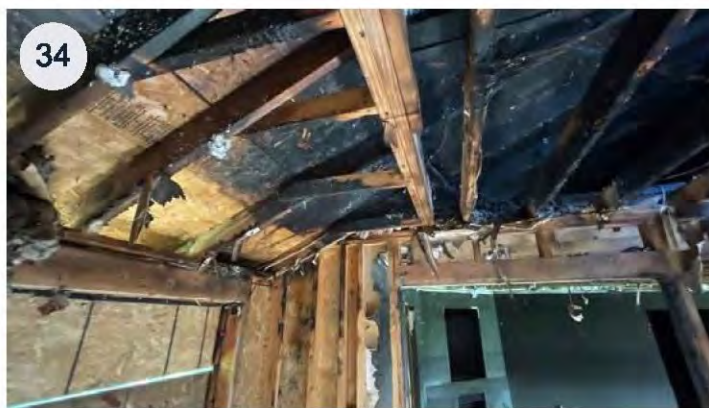
View of charred roof framing and decking above the kitchen.

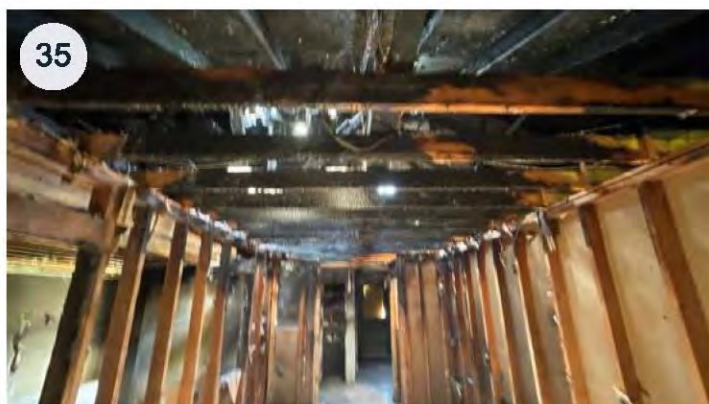
The extensive fire damage to the roof framing and to the ceiling joists above the kitchen compromised the framing of the dwelling. The efforts necessary to disassemble and reconstruct this portion of the dwelling will expose work crews to safety hazards. The inherent hazards related to the removal and reconstruction of the area above the kitchen should be considered as a limiting factor for the feasibility of completing the necessary repairs.

The ceiling joists above the kitchen were heavily charred.

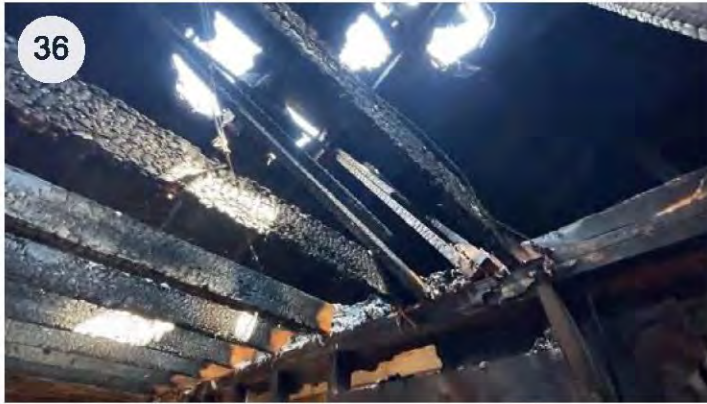
Additional view of the burned ceiling joists above the kitchen.

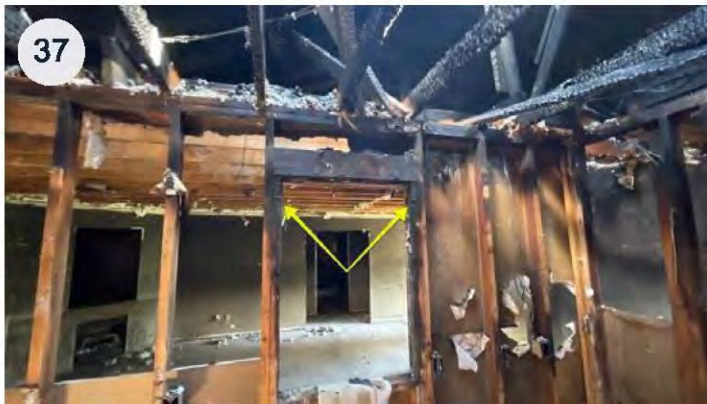
The wall studs along the sides of the kitchen pass through were charred.

2. Removal and reconstruction of the burned studs along the pass through on the kitchen wall along the south side of the kitchen. Removal and reconstruction of the burned/charred framing along the perimeter walls of the kitchen, pantry, and hallway.

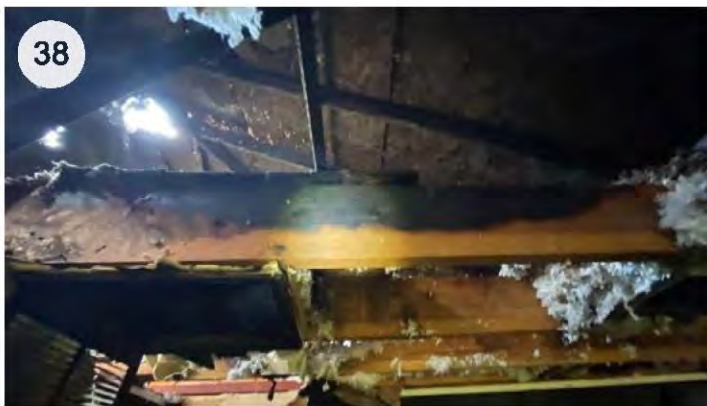
View of charring and soot to ceiling joists. It appeared that the presence of attic insulation limited the spread of the fire back into the dwelling.

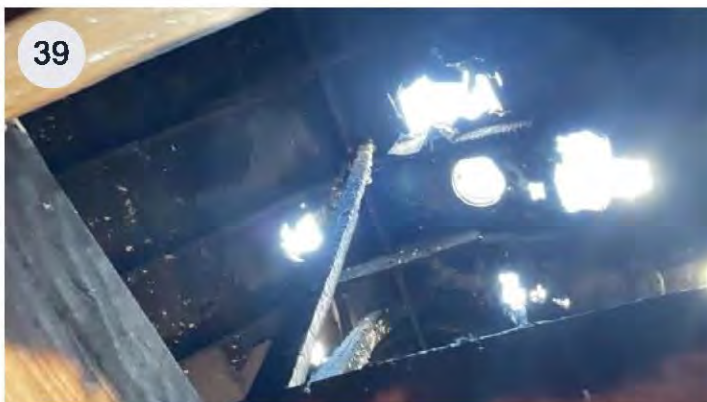
The fire primarily extended from the kitchen and into the attic. The interior finishes had been removed from much of the dwelling prior to the site evaluation. Fire damage was noted to the ceiling rafters above the kitchen and north end of the dwelling (burned primarily from the attic side). Soot was present to the limited remaining sections of the interior wall board wall and ceiling surfaces. As such, **it is recommended to consult with a properly credentialed industrial hygienist to determine the scope of repairs/cleaning necessary to restore the east side of the dwelling and/or other portions of the dwelling not otherwise reconstructed. The industrial hygienist should also provide recommendations relative to the remediation of the continued water intrusions and damage to the remaining wall board wall and ceilings surfaces of the dwelling due to the burn through holes within the roof system.**

View of the charred framing and burn through holes to the roof decking above the kitchen.
